# Manhole Inspection Summary

Manhole # S41AA\_015MH

Insp Date: **11/28/07 11:44 AM**

**Location** Address: **1308 e.monument**

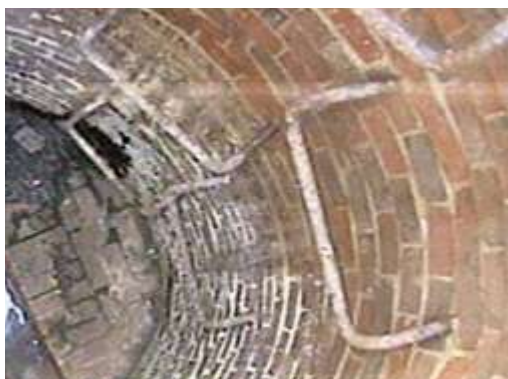
Defect 1

Count: **5** Missing: **0** ☒ Corroded

steps

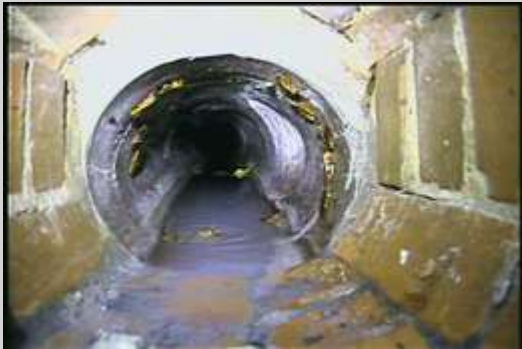
12 O'Clock Outflow

8 in. Circular Gravity Sewer  
Pipe Out @ 12 O'Clock

Pipe Material: **Clay** ☐ Pipe Lined

Invert Depth: 10.00 (ft.) Flow Characteristics: **Slow**

Deposits: ☒ None ☐ Mud ☐ Sludge ☐ Debris ☐ Grease

Infiltration: **None** Pipe Seal Cond: **Unknown**

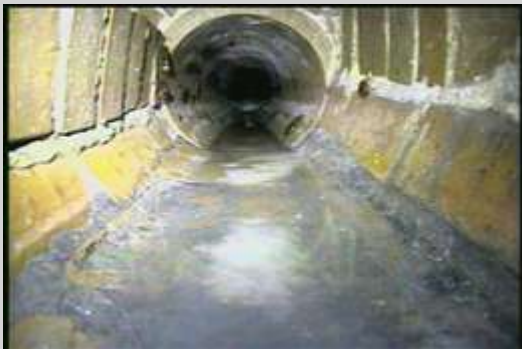
6 O'Clock Inflow

8 in. Circular Gravity Sewer  
Pipe In @ 6 O'Clock

Pipe Material: **Clay** ☐ Pipe Lined

Invert Depth: 9.90 (ft.) Flow Characteristics: **Slow**

Deposits: ☒ None ☐ Mud ☐ Sludge ☐ Debris ☐ Grease

Infiltration: **None** Pipe Seal Cond: **Unknown**

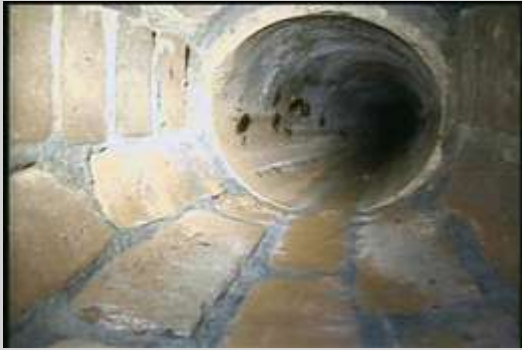
9 O'Clock Inflow

8 in. Circular Gravity Sewer  
Pipe In @ 9 O'Clock

Pipe Material: **Clay** ☐ Pipe Lined

Invert Depth: **9.90** (ft.) Flow Characteristics: **Slow**

Deposits: ☒ None ☐ Mud ☐ Sludge ☐ Debris ☐ Grease

Infiltration: **None** Pipe Seal Cond: **Unknown**
